Re: French Brothers Inc/Sonoma Ranch East Phase 9; CGP; SIC 1521; NPDES Compliance Evaluation Inspection; NPDES #NMU001984; February 13, 2019

French Brothers Inc Sonoma Ranch East Phase 9 Compliance Evaluation Inspection February 13, 2019 NPDES Permit No. NMU0001984 Further Explanations

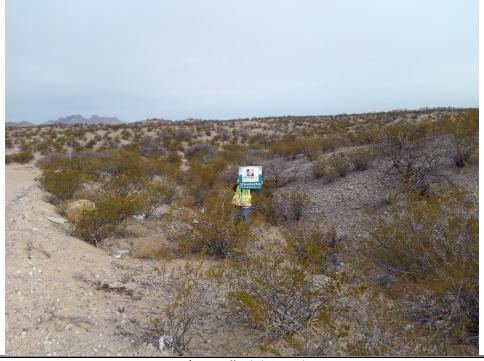
Two signs were found windblown in an arroyo to the north of the site (photo 1). There are signs of concrete and stucco washout directly on the ground on lots with a French Brothers sign (photo 2). In general, the practice in the area for BMPs is a 6 month tackifier application and a berm around the lot. Several berms on lots with French Brothers signs had not been maintained and had eroded through, allowing runoff to leave the home sites.

NMED/SWQB Official Photograph Log Photo # 1					
Photographer: Jennifer Foote	Date: 2/13/19	Time: 8:57 am			
City/County: Las Cruces/Dona Ana		State: New Mexico			
Location: Sonoma Ranch East Phase 9					
Subject: Windblown debris in drainage channel to north of site

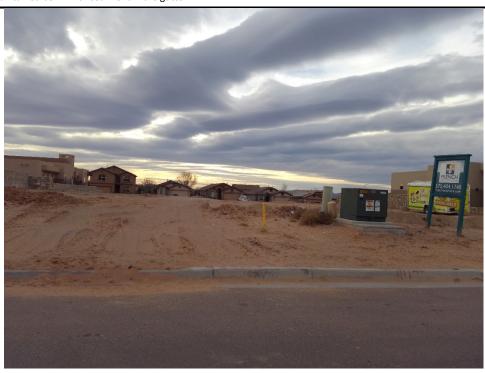
NMED/SWQB Official Photograph Log						
Photo # 2						
Photographer: Jennifer Foote	Date: 2/13/19	Time: 4:48pm				
City/County: Las Cruces/Dona Ana		State: New Mexico				
Location: Sonoma Ranch East Phase 9						
Subject: unmaintained berm with sediment in the gutter

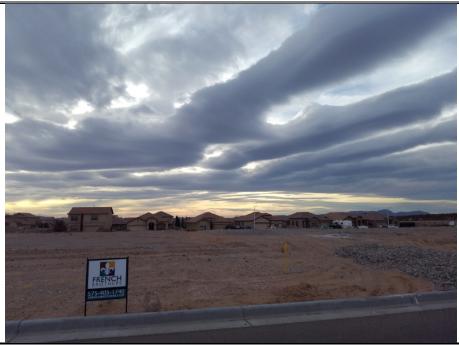
NMED/SWQB Official Photograph Log Photo # 3						
Photographer: Jennifer Foote	Date: 2/13/19	Time: 4:48 pm				
City/County: Las Cruces/Dona Ana		State: New Mexico				
Location: Sonoma Ranch East Phase 9						
Subject: construction entrance with concrete washout in the distance

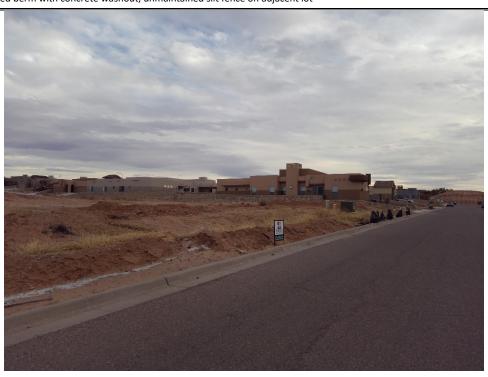
NMED/SWQB Official Photograph Log Photo # 4					
Photographer: Jennifer Foote	Date: 2/13/19	Time: 4:51 pm			
City/County: Las Cruces/Dona Ana		State: New Mexico			
Location: Sonoma Ranch East Phase 9					
Subject: Eroded berm with concrete washout, unmaintained silt fence on adjacent lot
